RAILROAD COMMISSION OF TEXAS

SURFACE MINING AND RECLAMATION DIVISION

RE: San Miguel Electric Coop, Inc.
San Miguel Mine, Permit No. 11G
Final Action Notification, NOV 114A

Statement of Inspector's Observations
Notice of Violation No. 114A
Issued to San Miguel Electrical Cooperative, Inc.
San Miguel Mine, Permit No. 11G

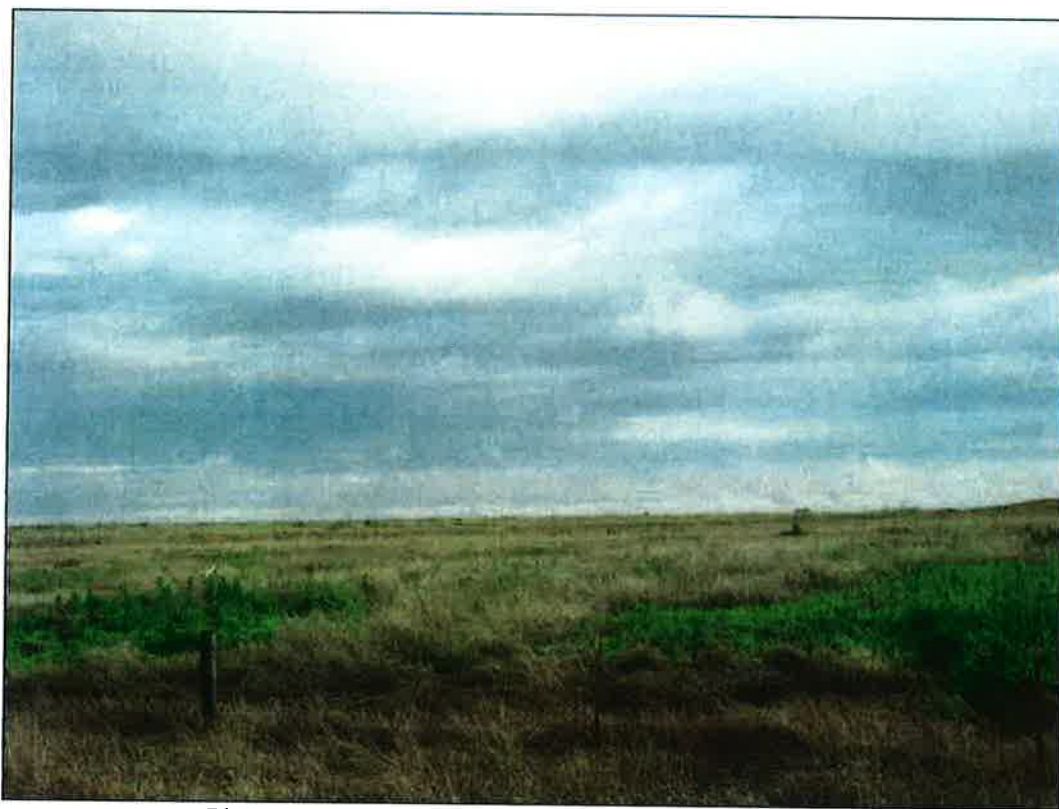
Vegetation has emerged from dormancy and is greening up on all areas of the mine (photo 1 and 2).

Photo 1. Typical vegetation in the A area (view south).

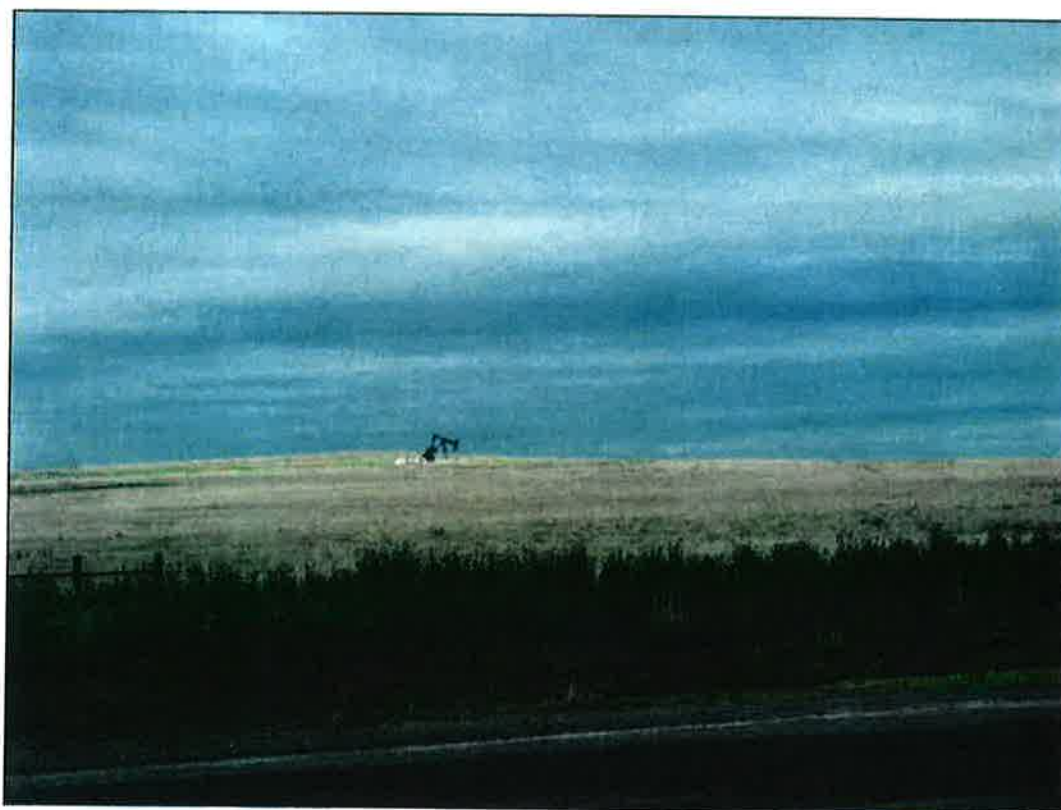
Photo 2. Typical vegetation in the E area (view northeast).

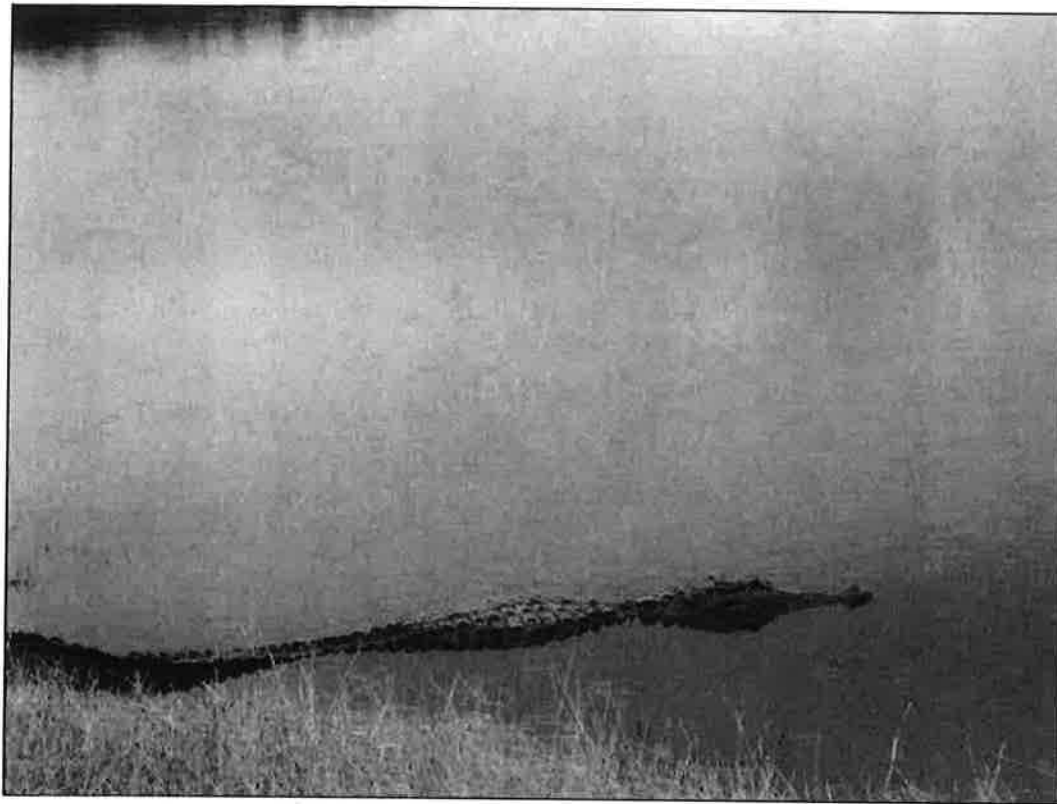
An alligator was observed in Pond G and an Upland Sandpiper was observed in the A area salt seep (photo 13 and 14).

Photo 13. Alligator in Pond G (view west).

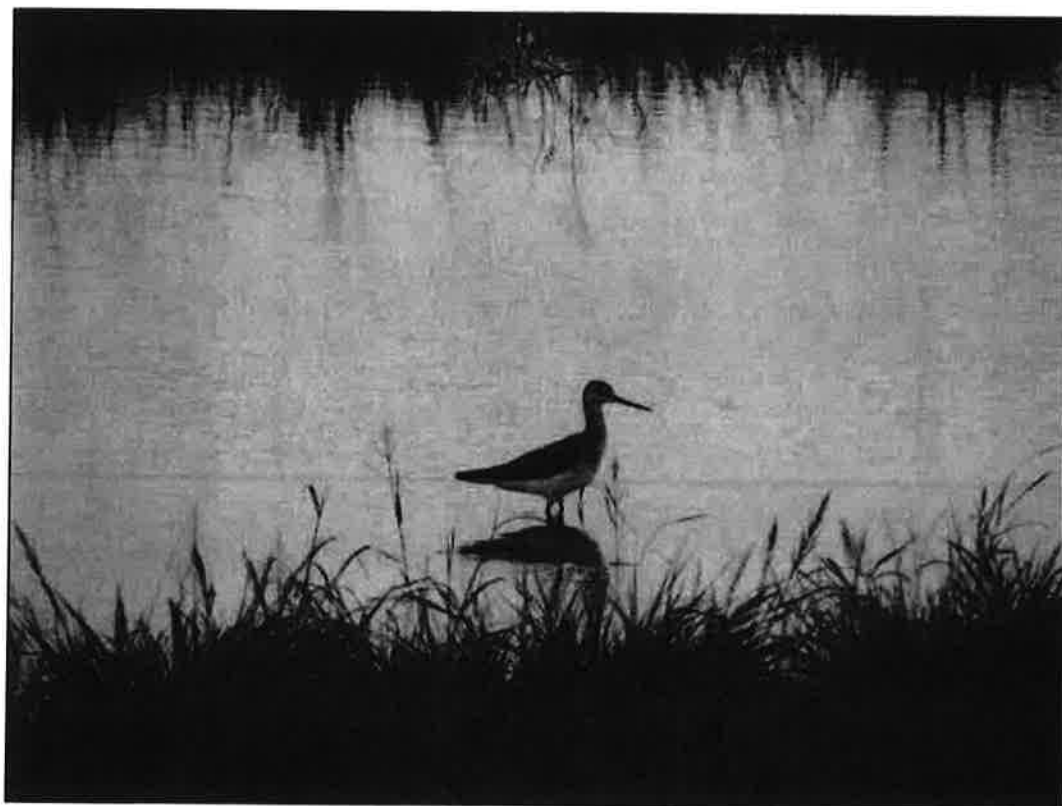
Photo 14. Upland Sandpiper (view south).
